Evaluation of Optical Materials Samples

FINAL REPORT

University of Dayton
Research Institute
Dayton, Ohio 45469

JULY 1988

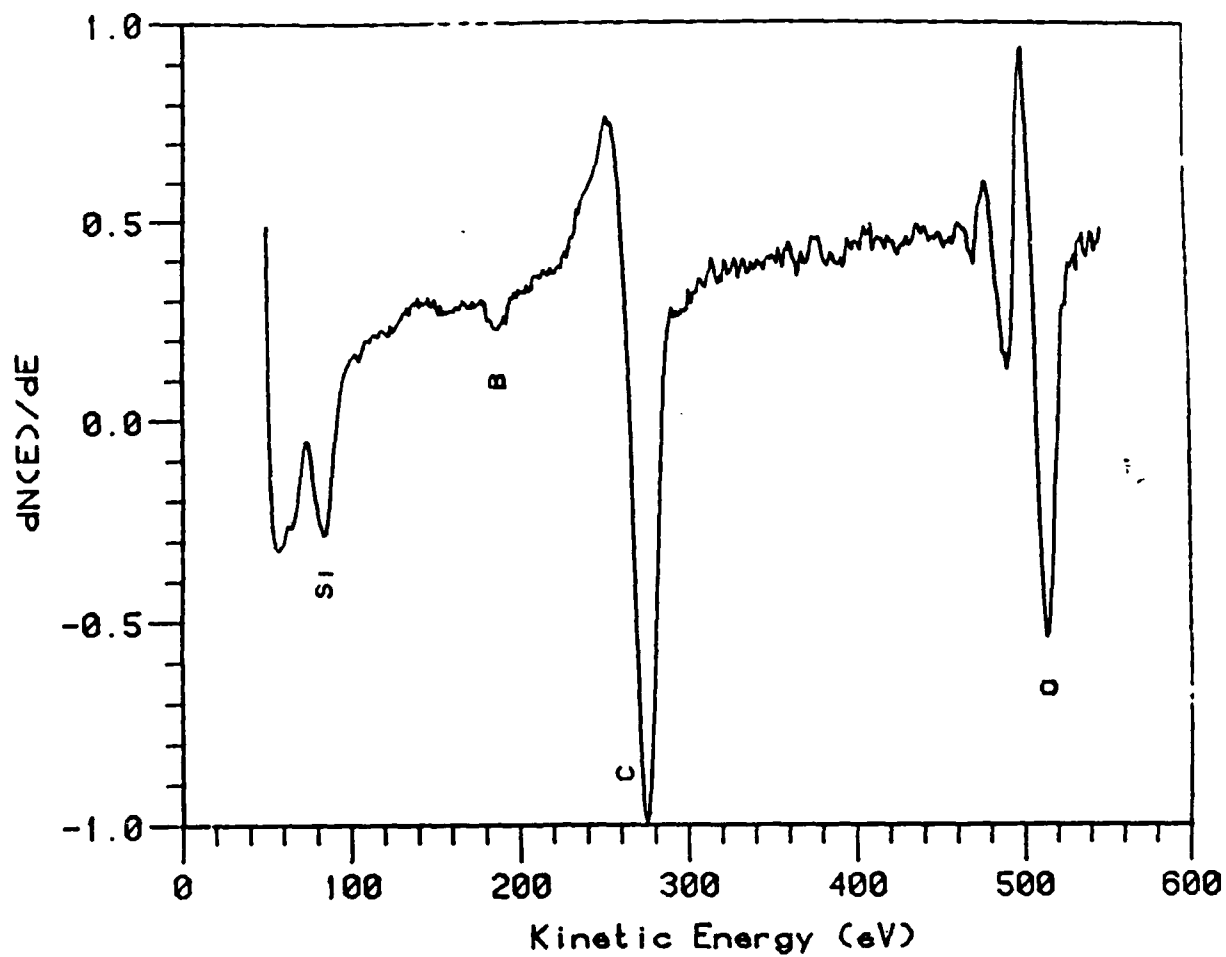
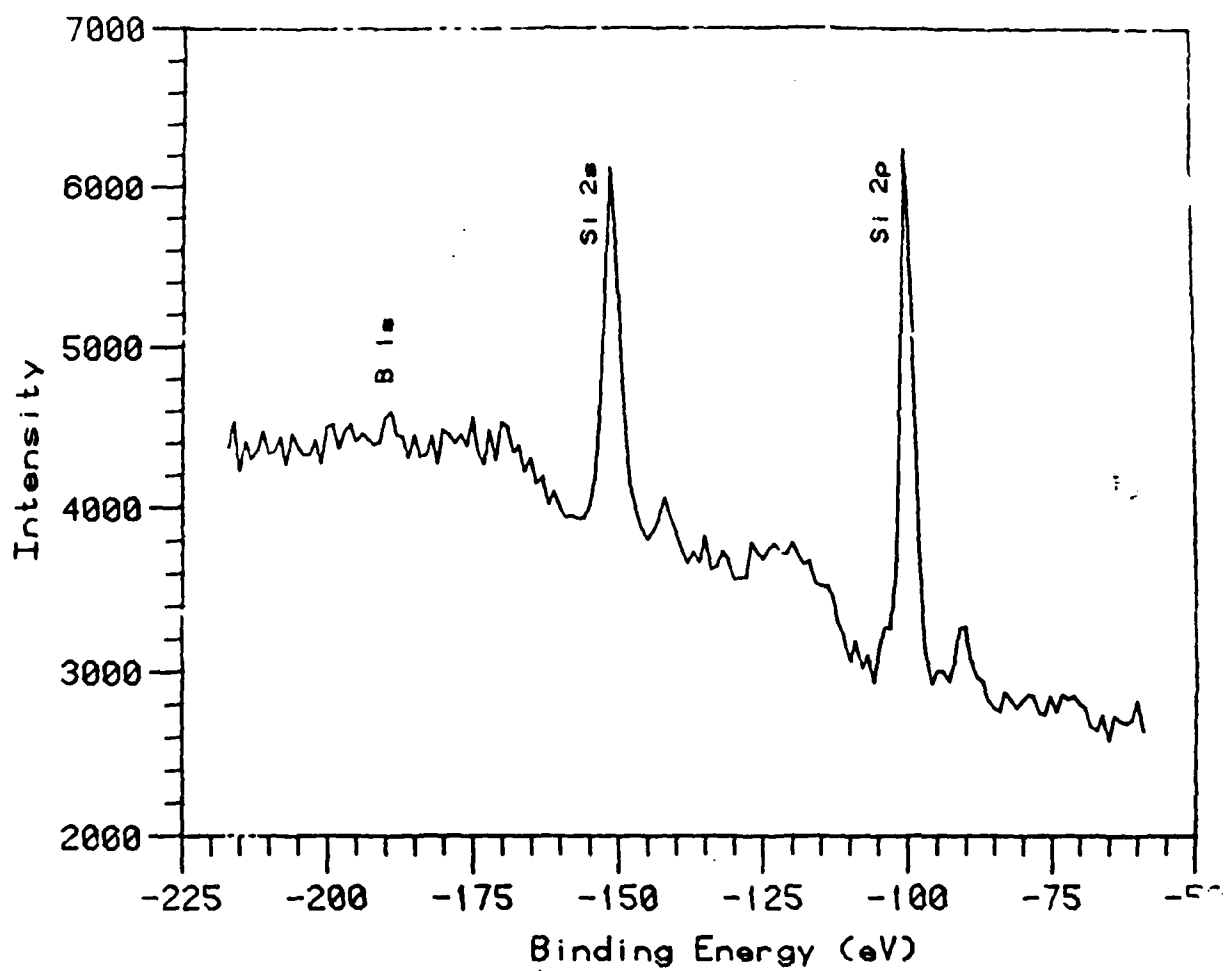
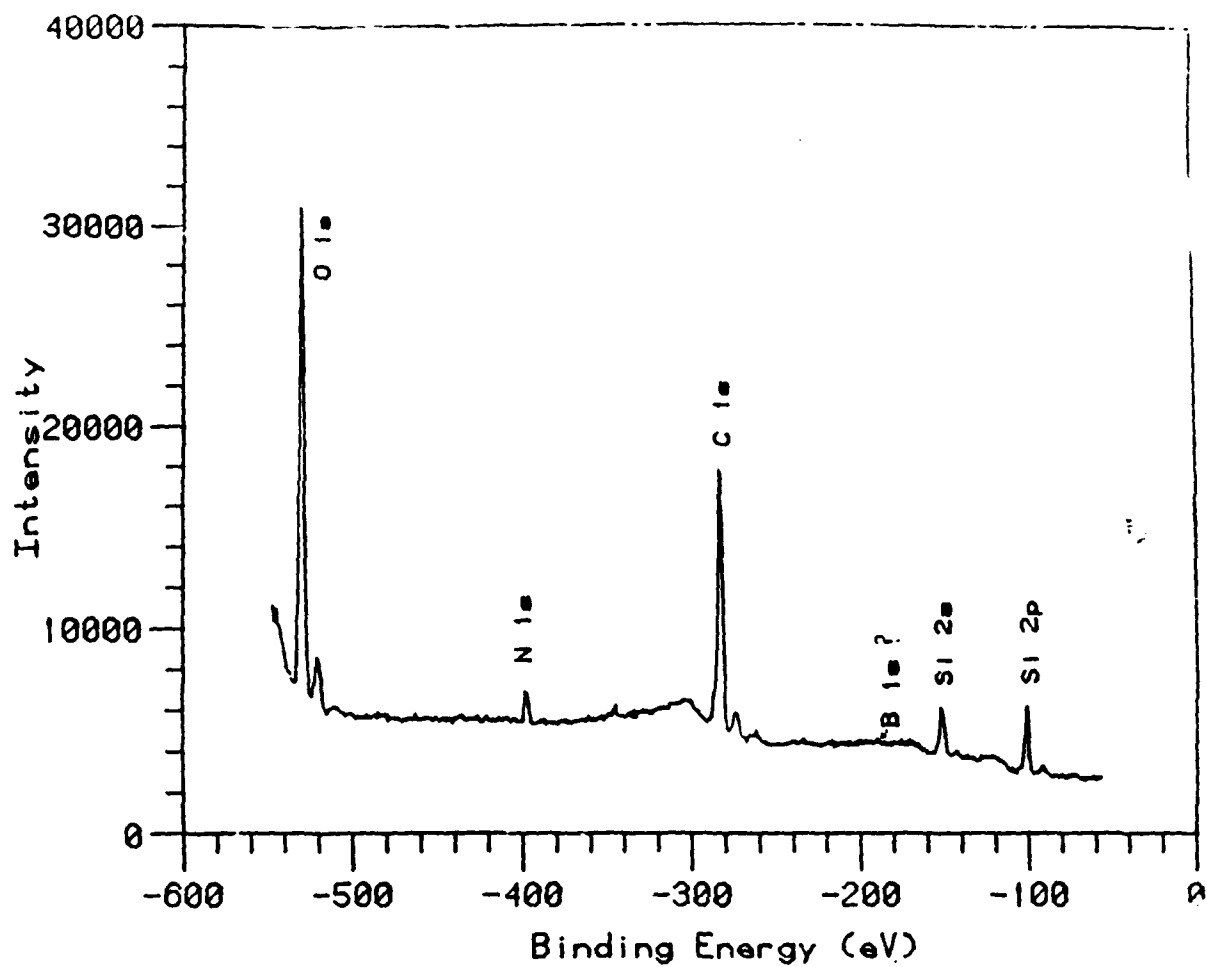
The results of the XRD analysis shown in Table 2 confirmed that the bulk porous material was only SiC. The Auger analysis, however, is more sensitive to the lighter elements and indicated the presence of O and B. Figures 27, 28, and 29 are ACS scans taken confirming that the contaminant was B and also a small amount of Fe. At the time, the presence of boron was not understood until it was discovered that boron carbide (B_4C) was used as the cutting agent in the ultrasonic machining operation. Figure 30 shows two regions investigated. Region 1 was a fracture area of a machined SiC post and region 2 an area of white "deposit". Figures 31 and 32 are magnified areas of regions 1 and 2, respectively.

Figure 29. SiC and B₄C AES surface scan.

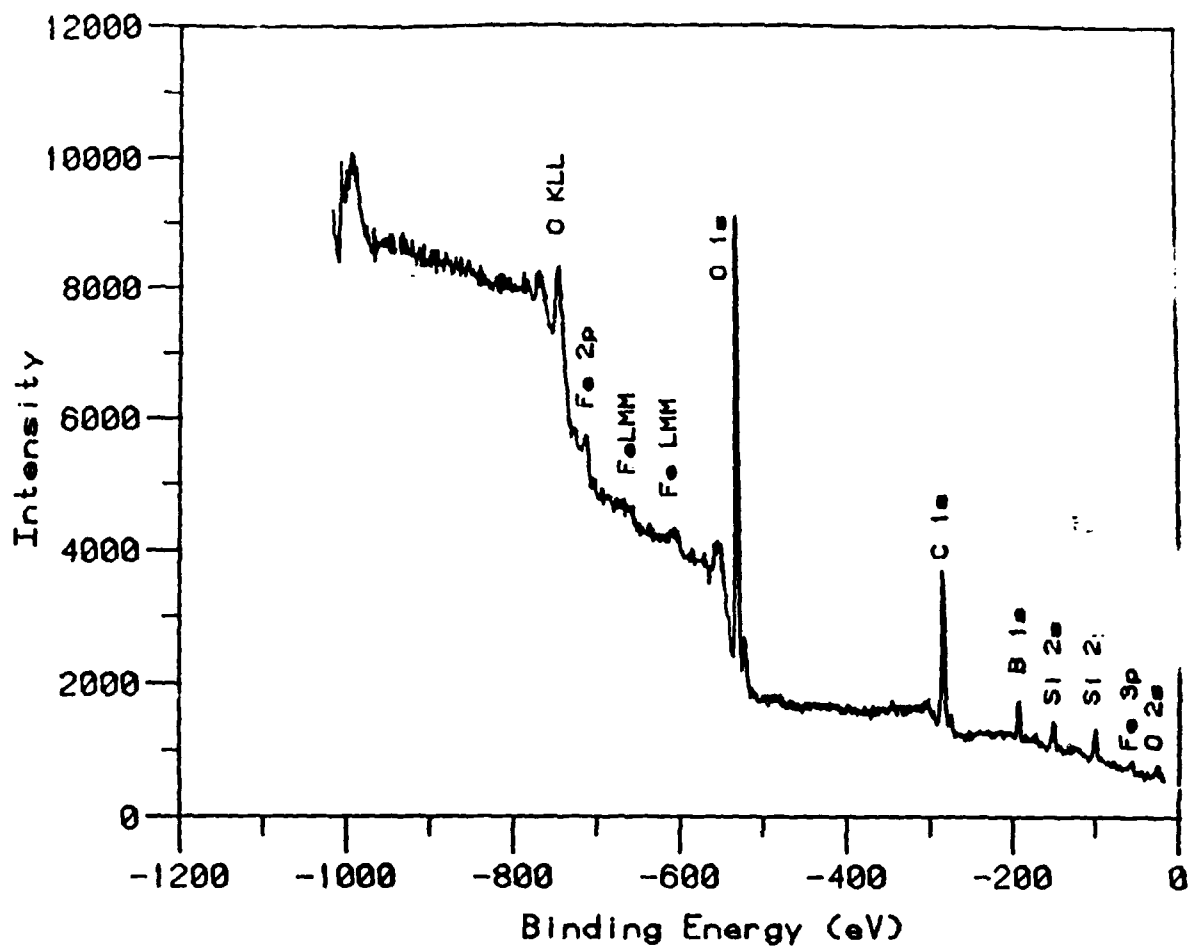
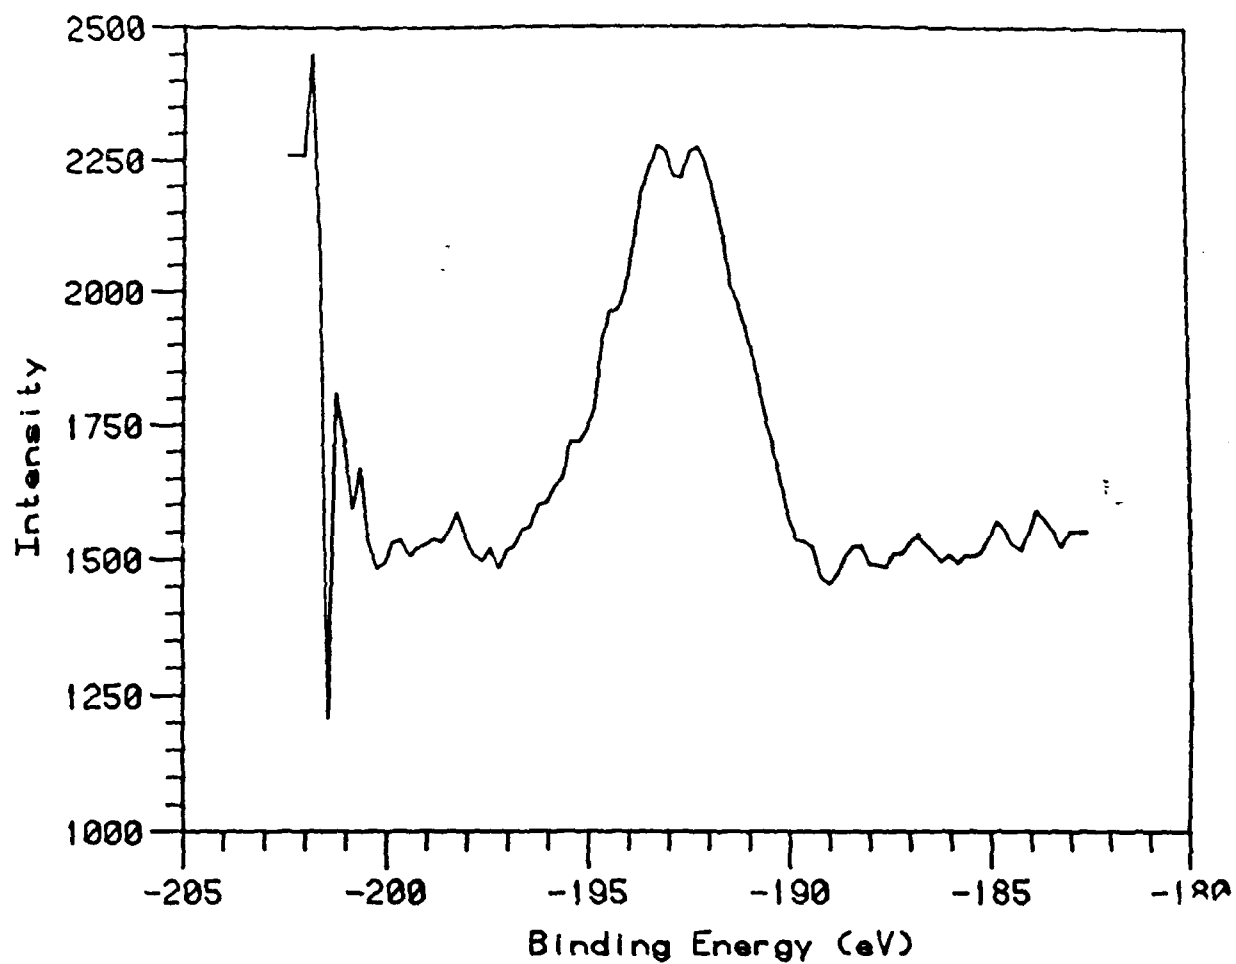
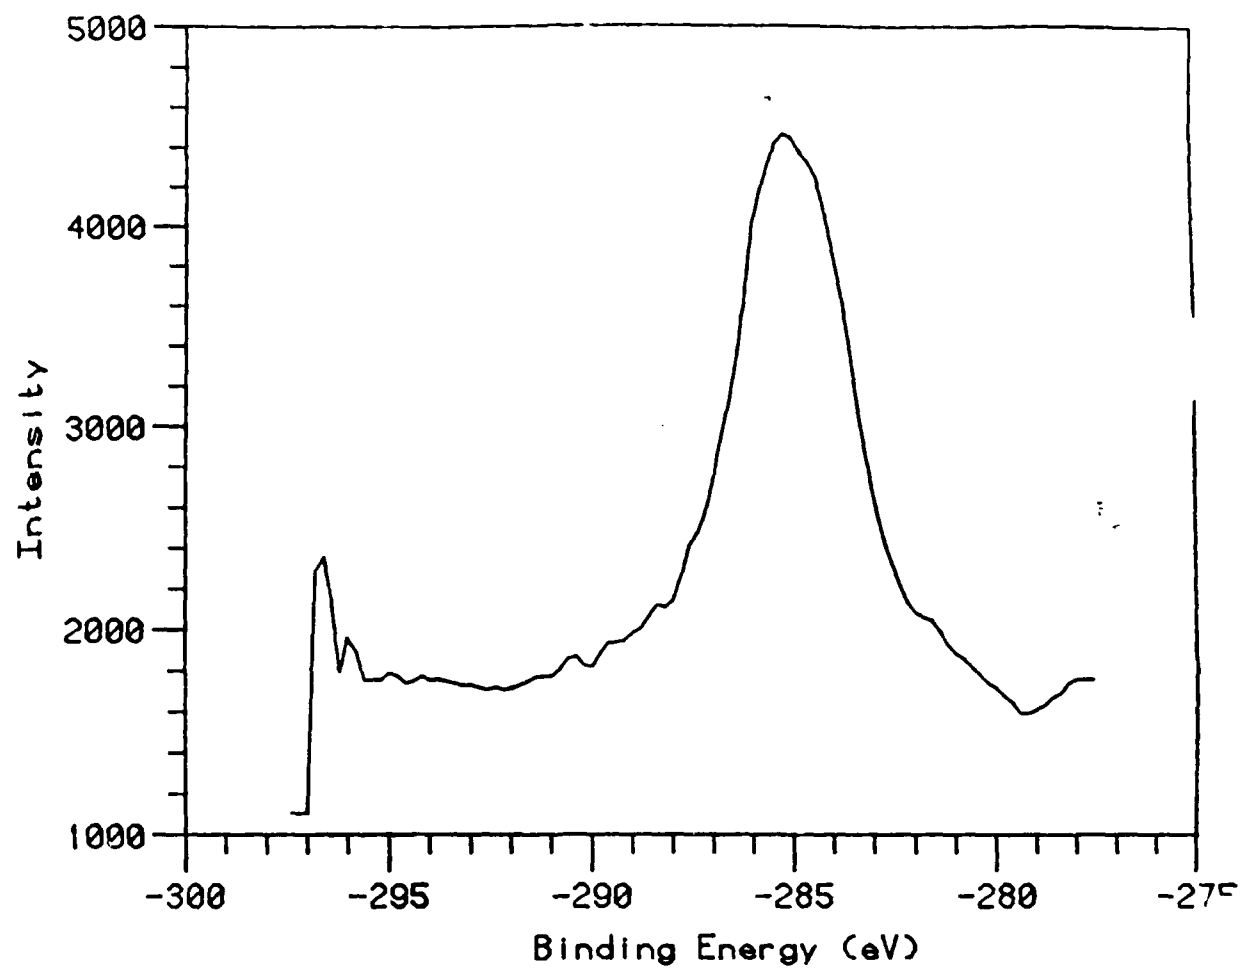
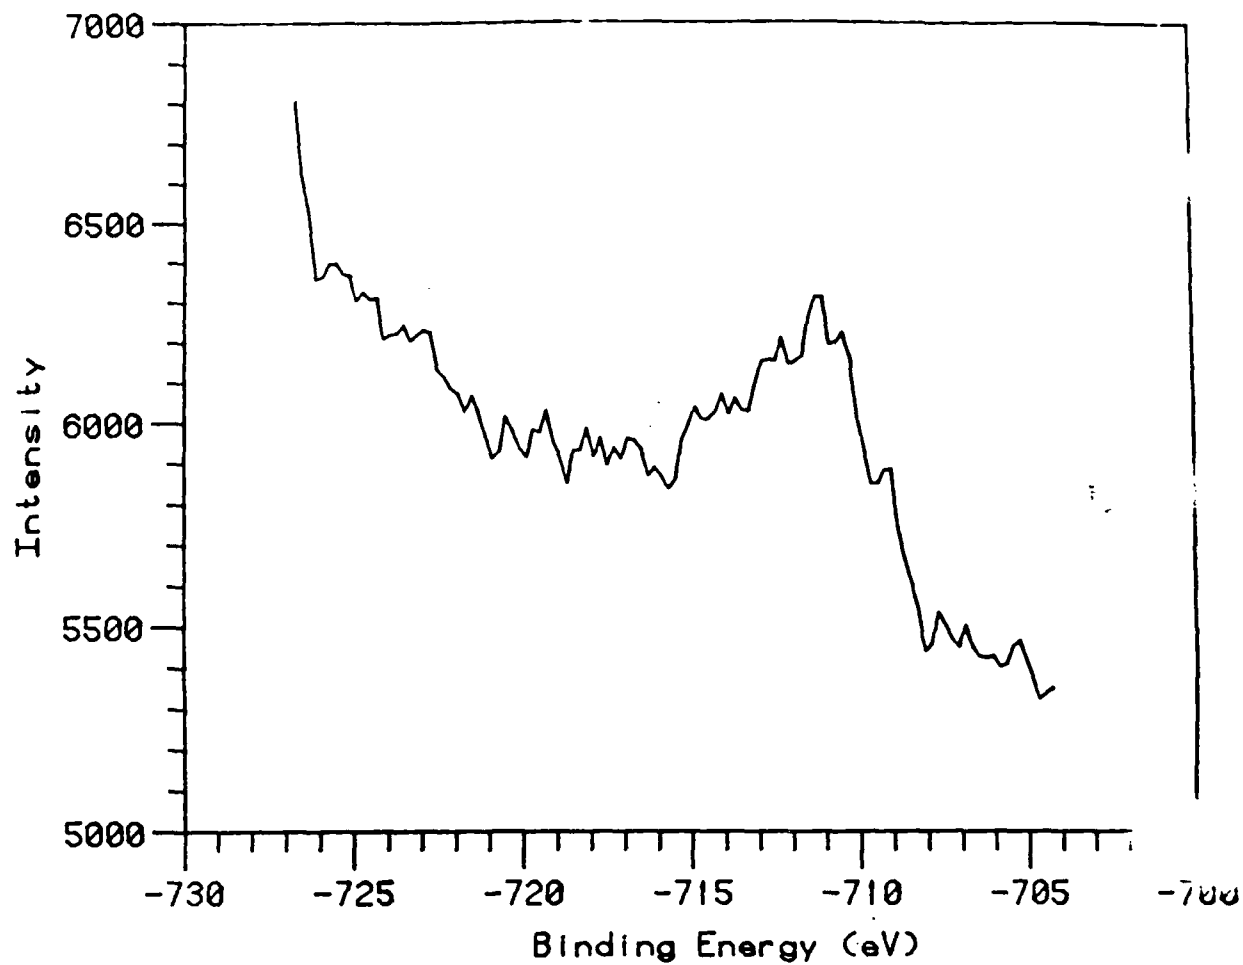
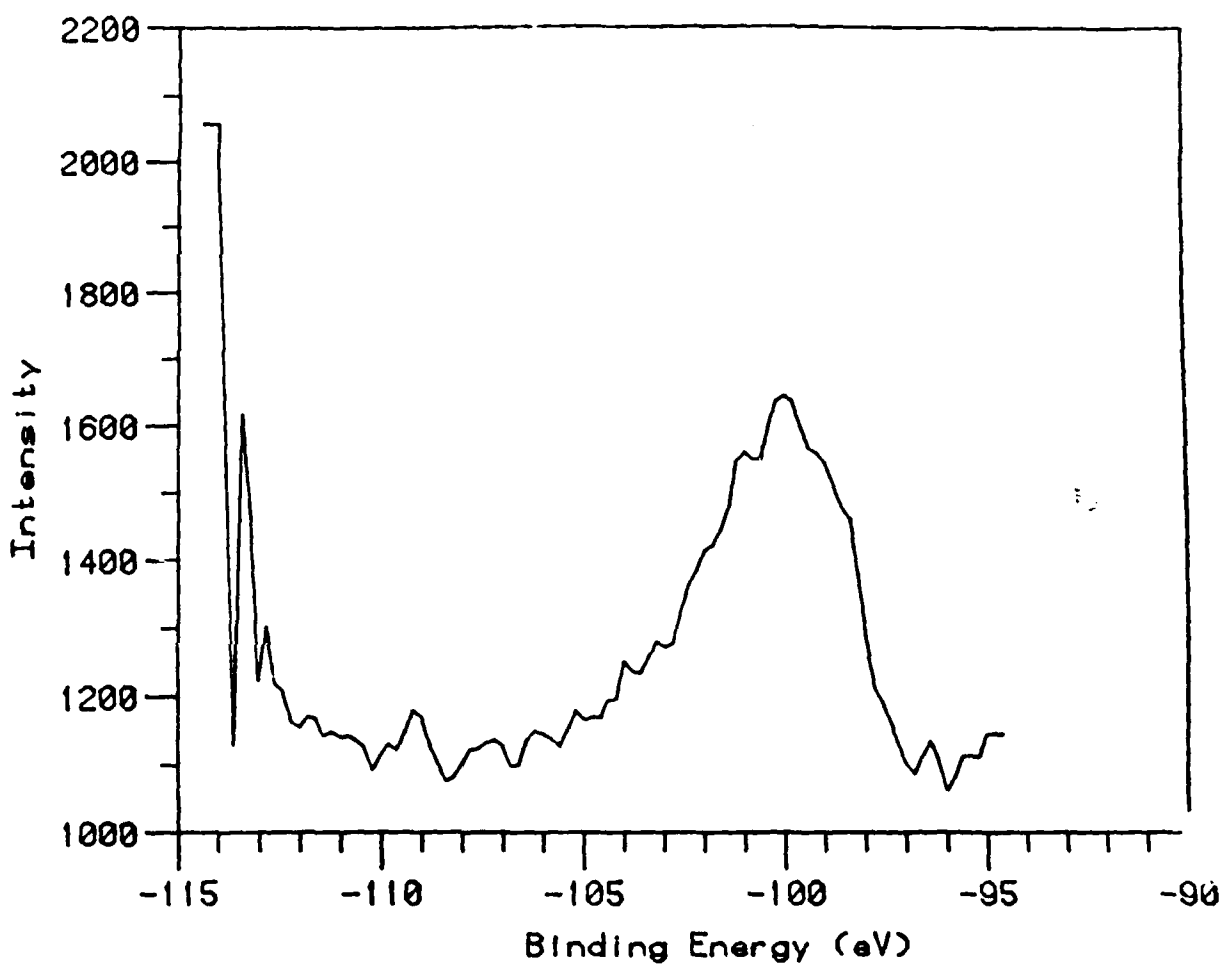
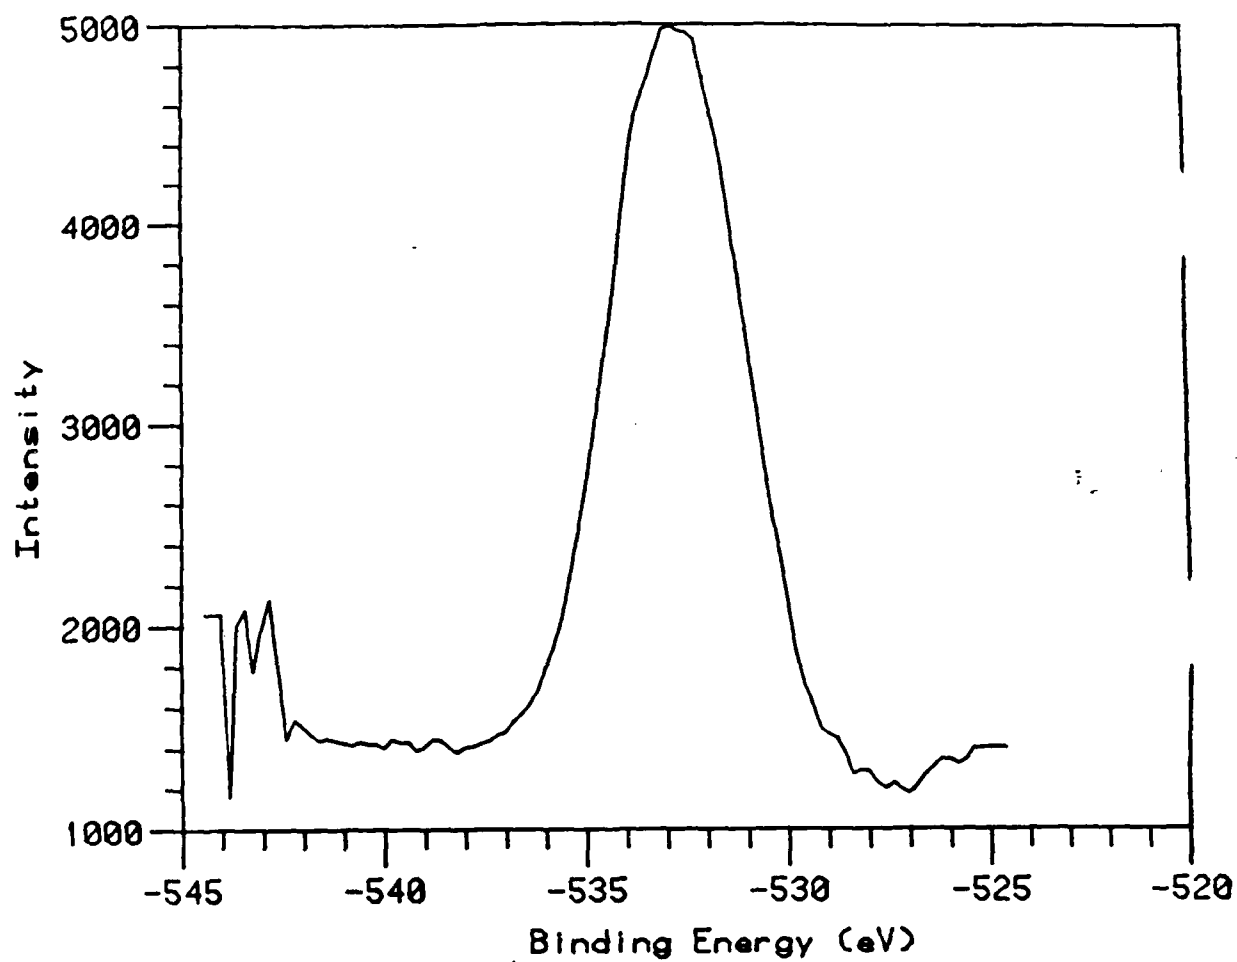
Further studies using an electron spectroscopy for chemical analysis apparatus (ESCA) (Figure 33) confirmed the Auger analysis and led to the conclusion that a borosilicate was formed through the combination of Si, B, O, and high temperature. The binding energy of the boron 1s peak, 192.7 eV, is quite close to that reported for B_2O_3 (193.0 eV). From the XPS data, there was no evidence of B_4C which should have a boron 1s peak at 186 eV. The silicon 2p peak is rather broad and asymmetrical. This is probably due to the presence of both SiC (peak at 100 eV) and an Si-O phase (peak at 102-103 eV). The oxygen 1s peak is also rather broad; this may be due to the fact that both hydroxides and oxides are present.

Figure 33. Porous SiC (side w/pins broken off) ESCA surface scan.
